Laboratory Test for Measurement of Adhesion Strength of Spray Ice to Coated Flat Plates

Nathan D. Mulherin, Jacqueline A. Richter-Menge,
Thomas J. Tantillo, Larry D. Gould, Glenn D. Durell,
and Bruce C. Elder

May 1990

**U.S. Army Corps
of Engineers**
Cold Regions Research &
Engineering Laboratory

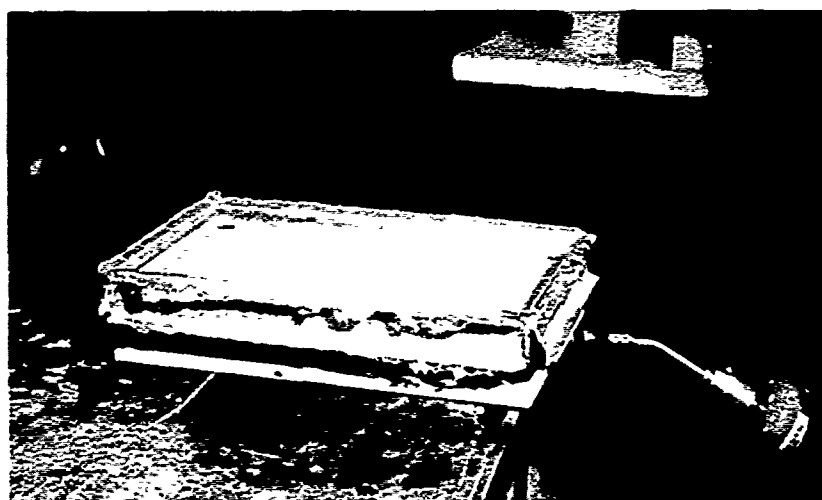
Figure 7. Galvanized dams being removed by lightly heating them with a propane torch.

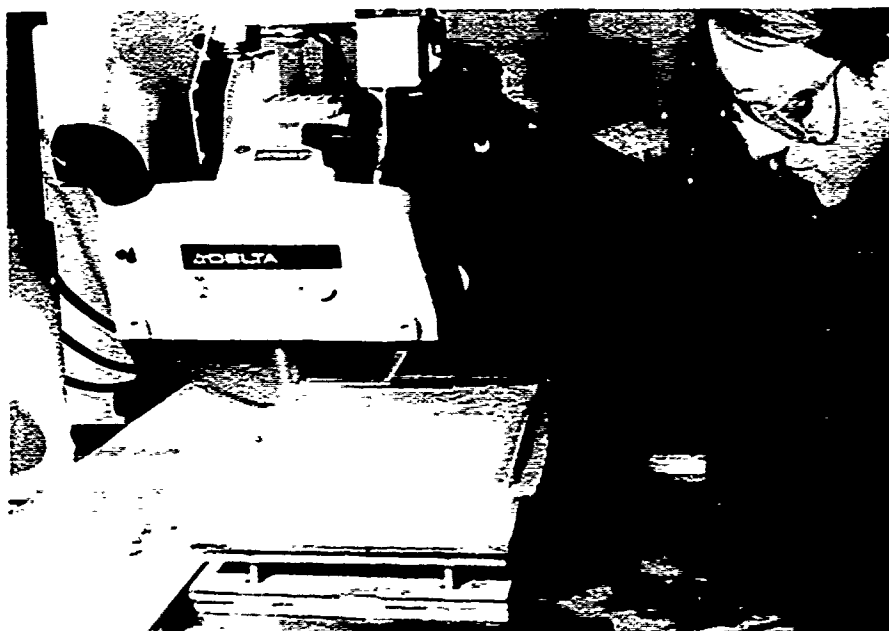
Figure 8. Sample edges being trimmed using a radial arm saw with a carbide-tipped blade.

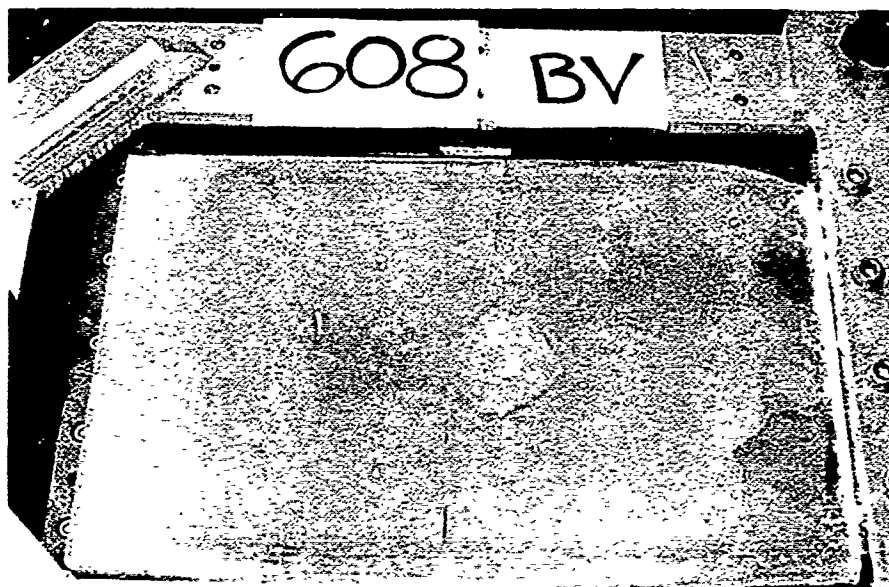
Figure 21. Typical sample with a freezing-relief fracture near its center and a shear fracture pattern that intersects with it. Loading direction is from R to L. Loading edge shows typical crushing and flaking caused by the beveled push bar.

If the freezing rate was not rapid enough, a reservoir of excess water became trapped within the ice. After the sprayer was turned off, the unfrozen water became concentrated near the center of the ice cover as the sample cooled from the outside inward. Complete water-to-ice phase change resulted in a "freezing relief" swelling with localized fractures in the swollen area.

This phenomenon occurred to varying degrees in 20 of the 72 samples. Figure 21 shows a typical example of freezing relief and a shear test fracture pattern that intersects with it.
